CALIFORNIA DIVISION OF MINES AND GEOLOGY  
FAULT EVALUATION REPORT FER-145

Faults East of Bakersfield, Kern County

February 6, 1984

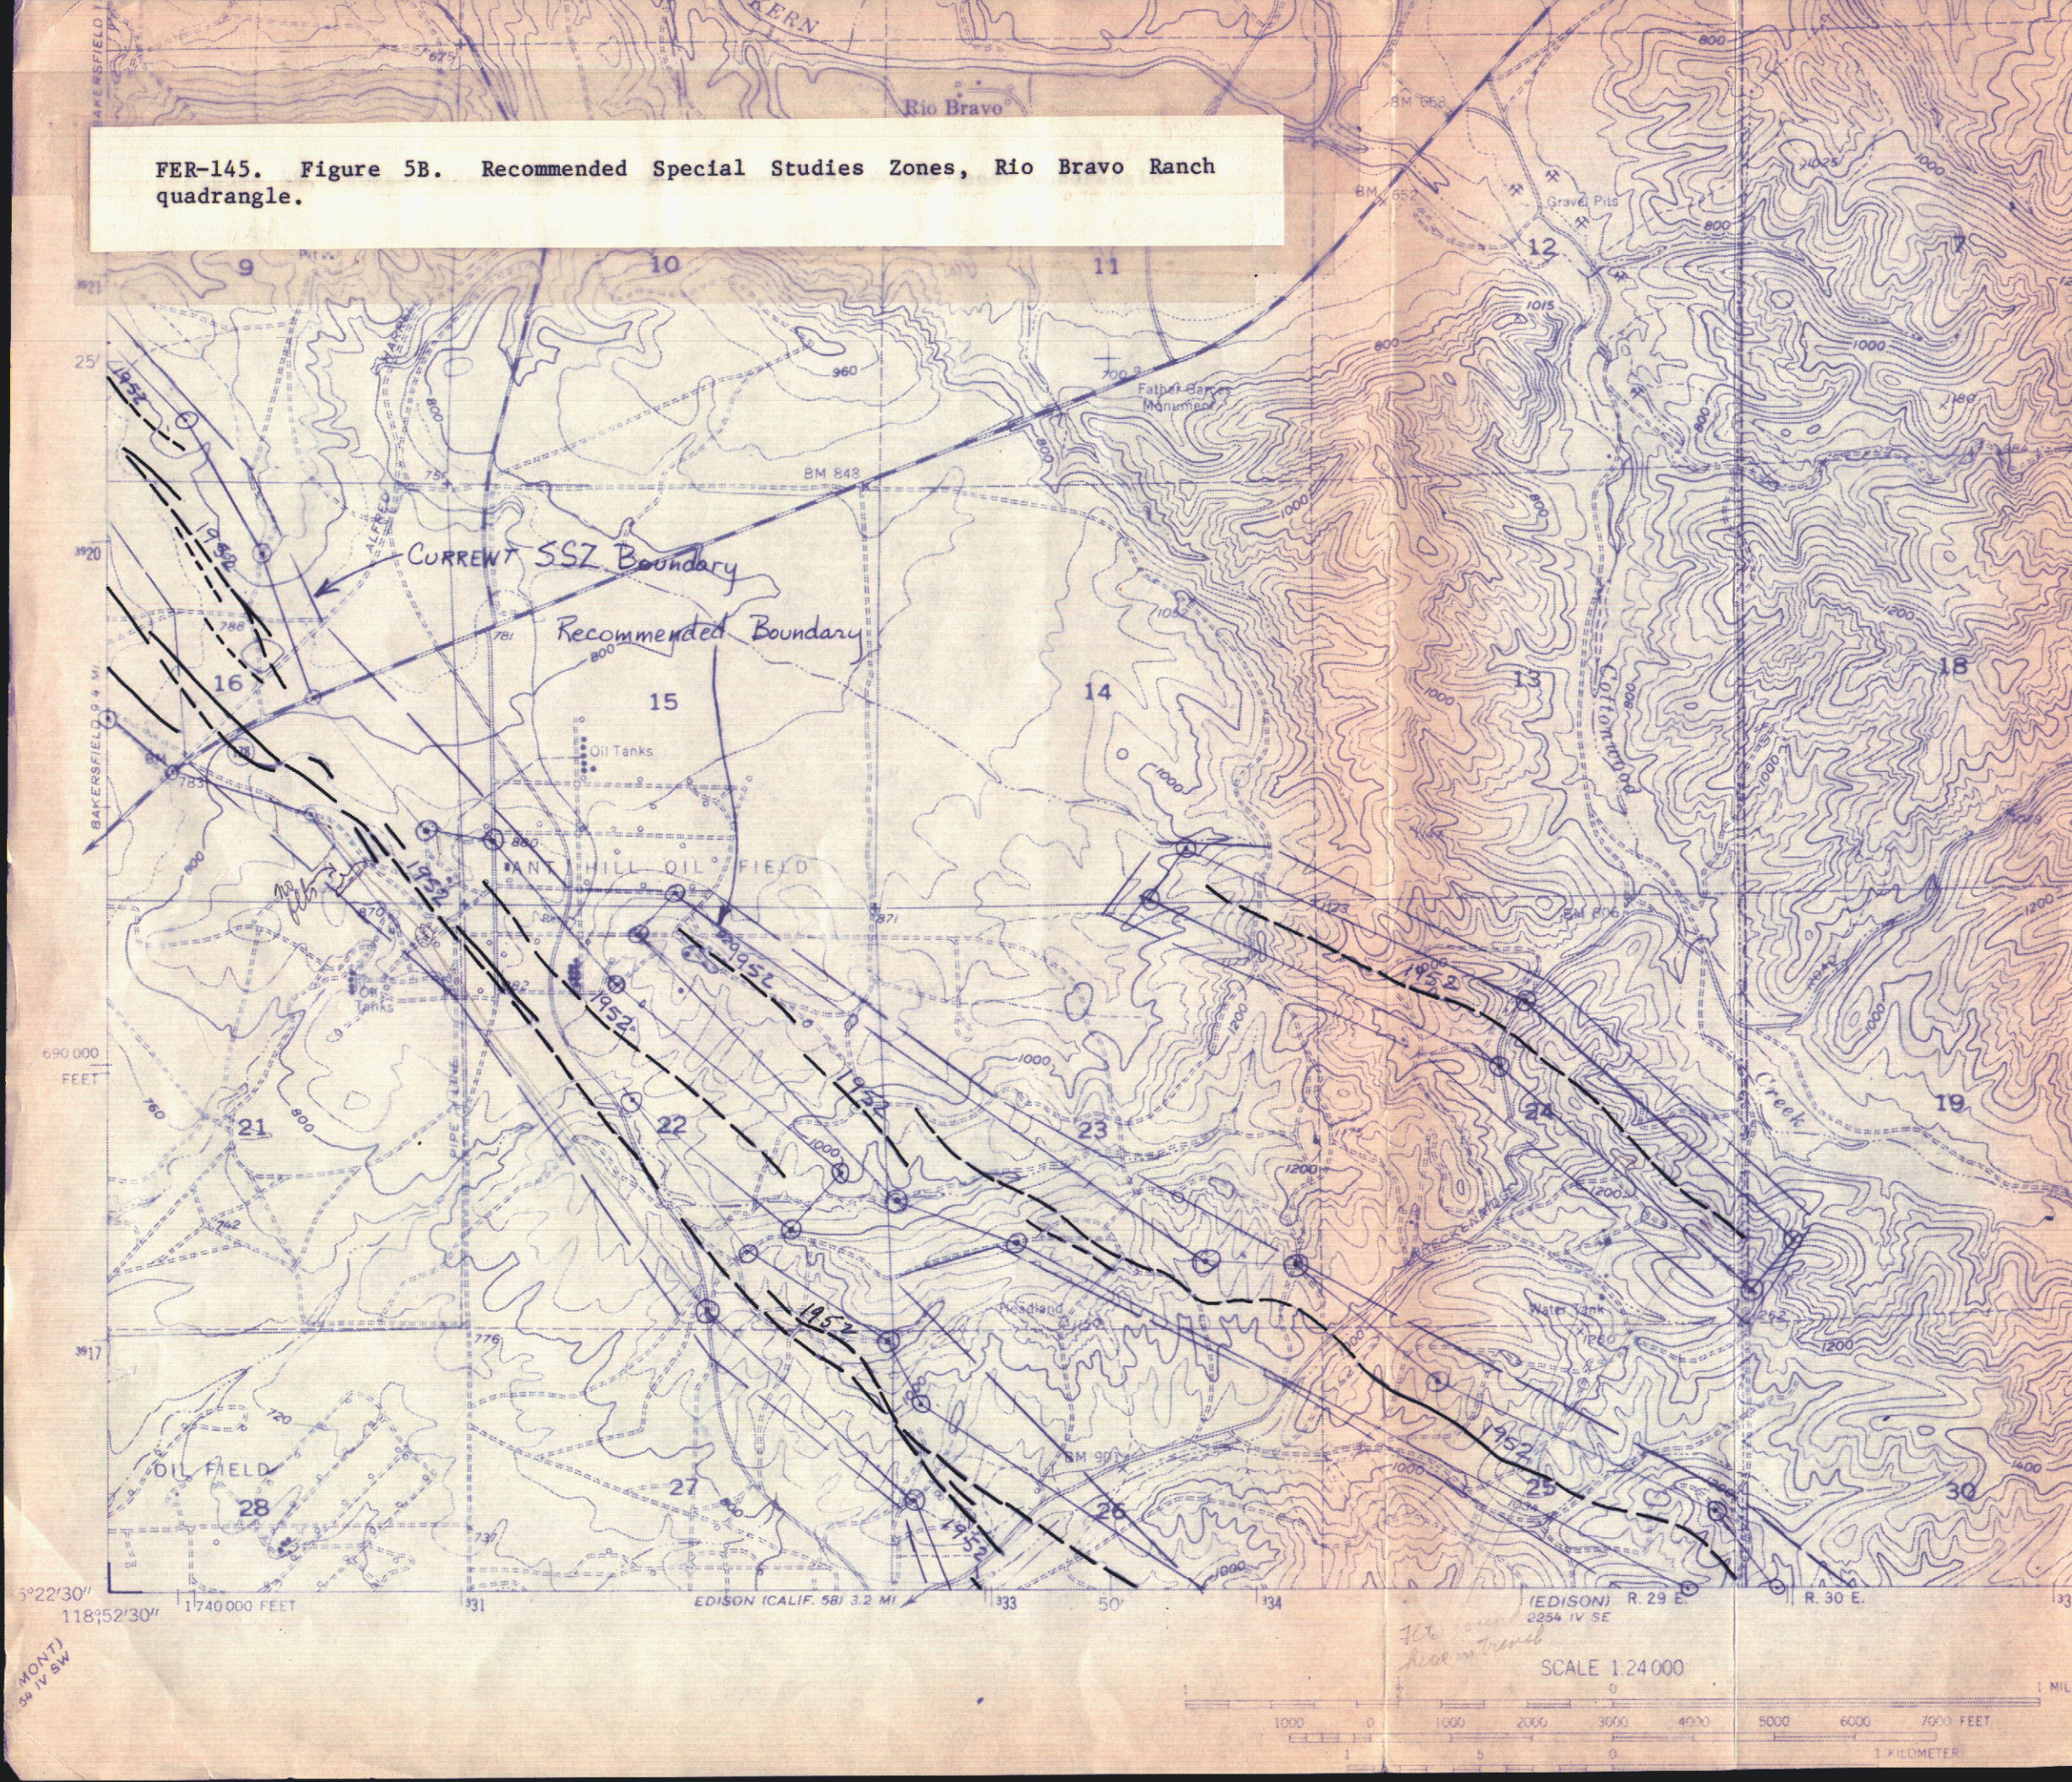
FER-145. Figure 5B. Recommended Special Studies Zones, Rio Bravo Ranch quadrangle.

Based on the above information and conclusions, revision of the existing SSZ maps of the Oil Center, Rio Bravo Ranch, and Edison quadrangles appears warranted. Figures 5A, 5B, and 5C show the recommended revised zones. Bruer, Robinson, and others (1952) and this FER should be the principal references cited.
